Manhole Inspection Summary

Manhole # S71Q__006MH

Location Address: **6711 Danville Ave.**

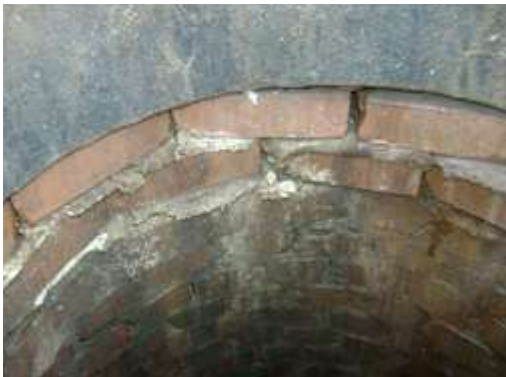
Defect 2

Condition: ☐ Sound ☐ Cracked ☐ Root Intrusion ☒ **Loose Brick** ☒ **Deteriorated**

Loose Bricks--chimney

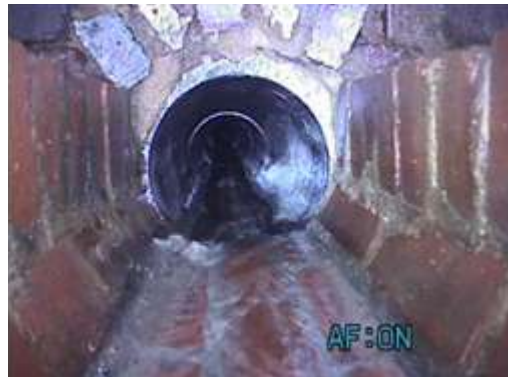
Defect 5

cracked pipe seal 12 to 2

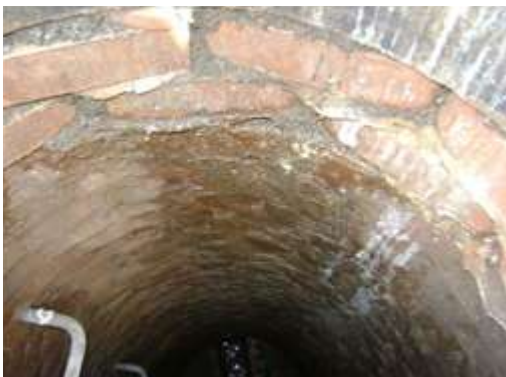
Defect 4

Infiltration: ☐ None ☐ Joint ☐ Cracks ☒ **Mortar** ☐ Roots ☐ Wall

Infiltration in mortar--corbel and chimney

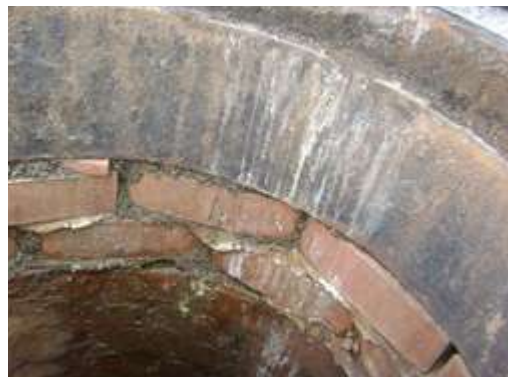
Defect 3

Deterioration--chimney

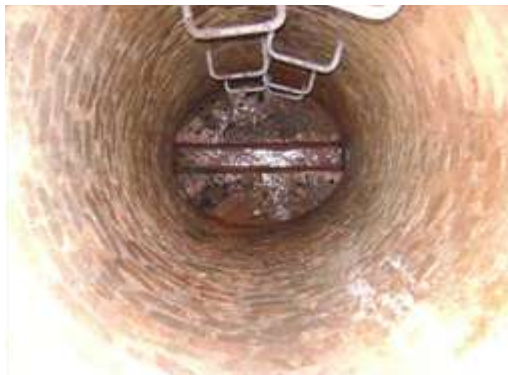
Defect 1

Infiltration-corbel

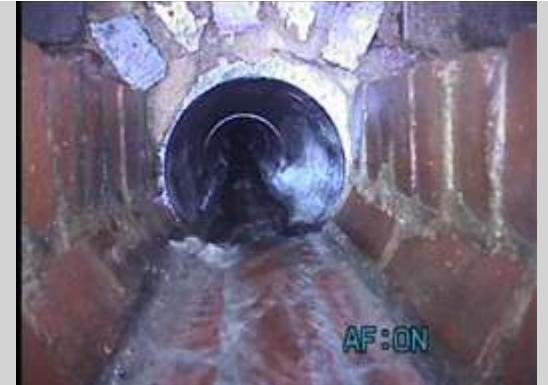
12 O'Clock Outflow

Pipe Height: **8.4** (in.) Rod and Bar (Angled)
Pipe Material: **Clay** ☐ Pipe Lined
Invert Depth: **13.92** (ft.) Flow Characteristics: **Fast**
Deposits: ☒ None ☐ Mud ☐ Sludge ☐ Debris ☐ Grease
Silt Depth: (in.) Deposits Extent:
Infiltration: **None** Pipe Seal Cond: **Sound**

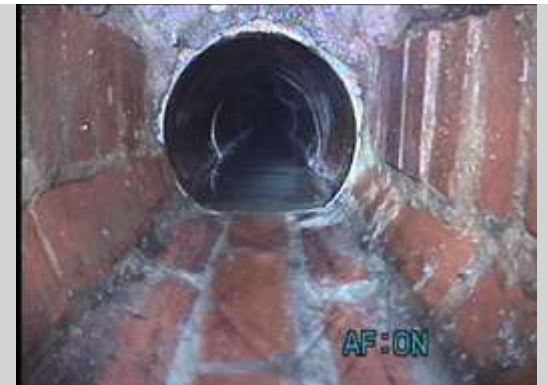
6 O'Clock Inflow

Pipe Height: **8.4** (in.) Rod and Bar (Angled)
Pipe Material: **Clay** ☐ Pipe Lined
Invert Depth: **13.08** (ft.) Flow Characteristics: **Fast**
Deposits: ☒ None ☐ Mud ☐ Sludge ☐ Debris ☐ Grease
Silt Depth: (in.) Deposits Extent:
Infiltration: **None** Pipe Seal Cond: **Sound**
